City of Charleston

Board of Architectural Review-SMALL

October 24, 2019

5 BOGARD STREET STRUCTURAL EVALUATION

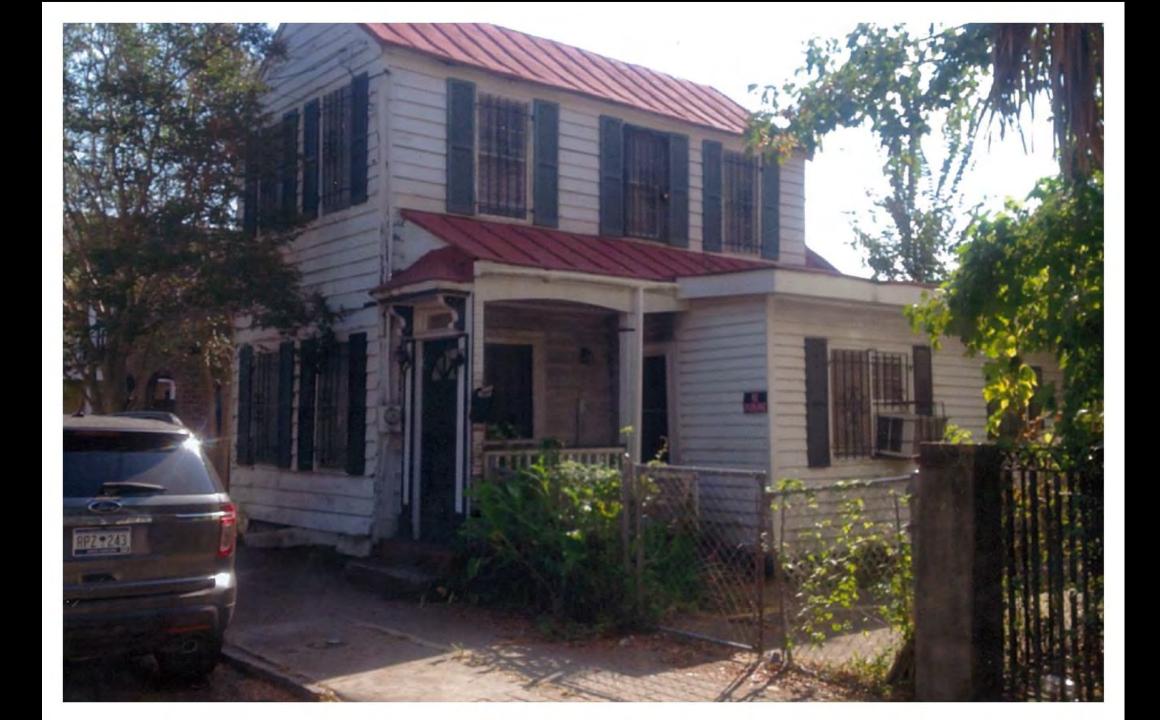
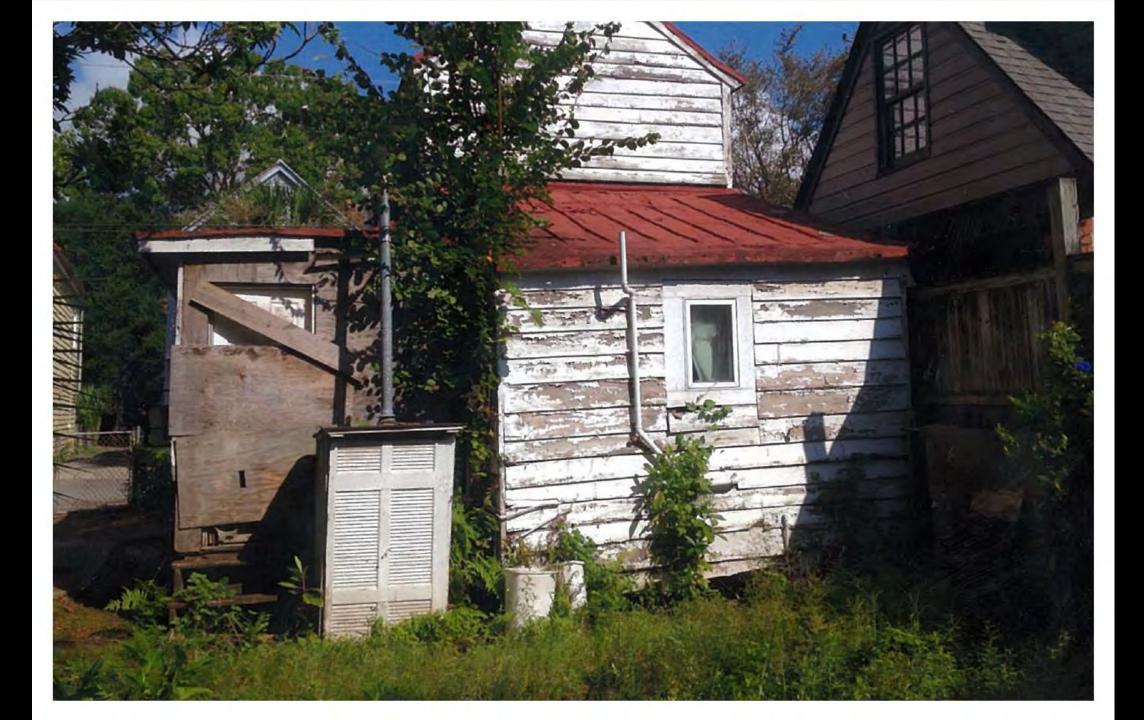
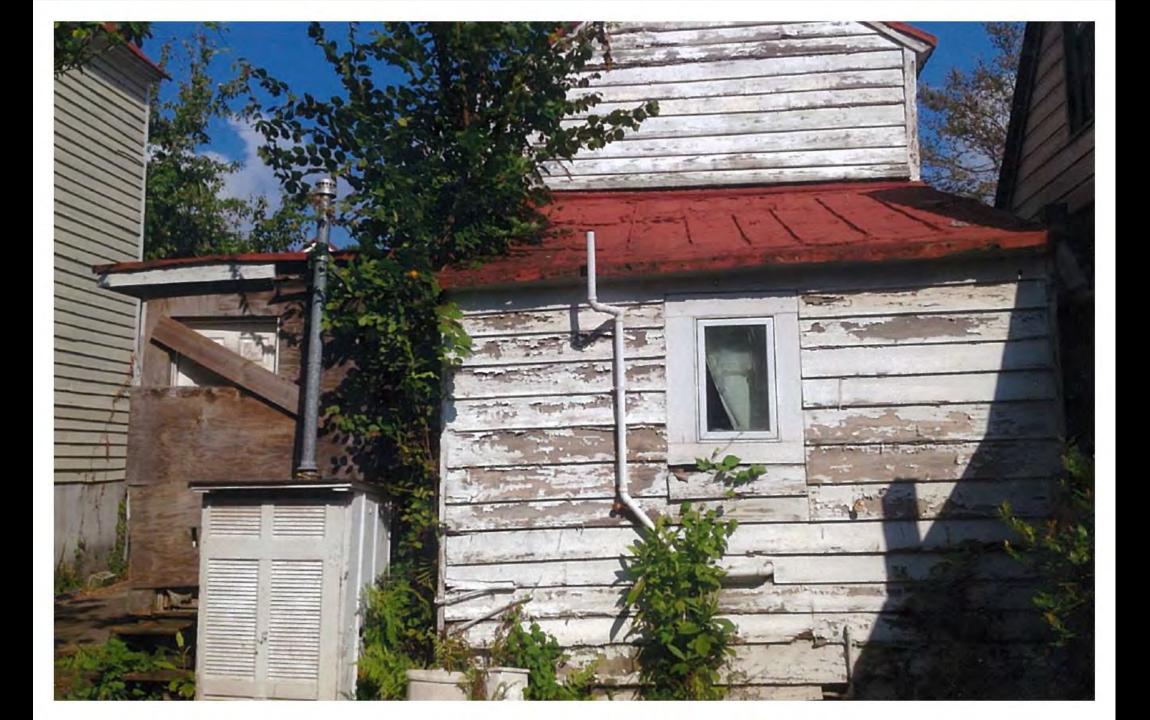
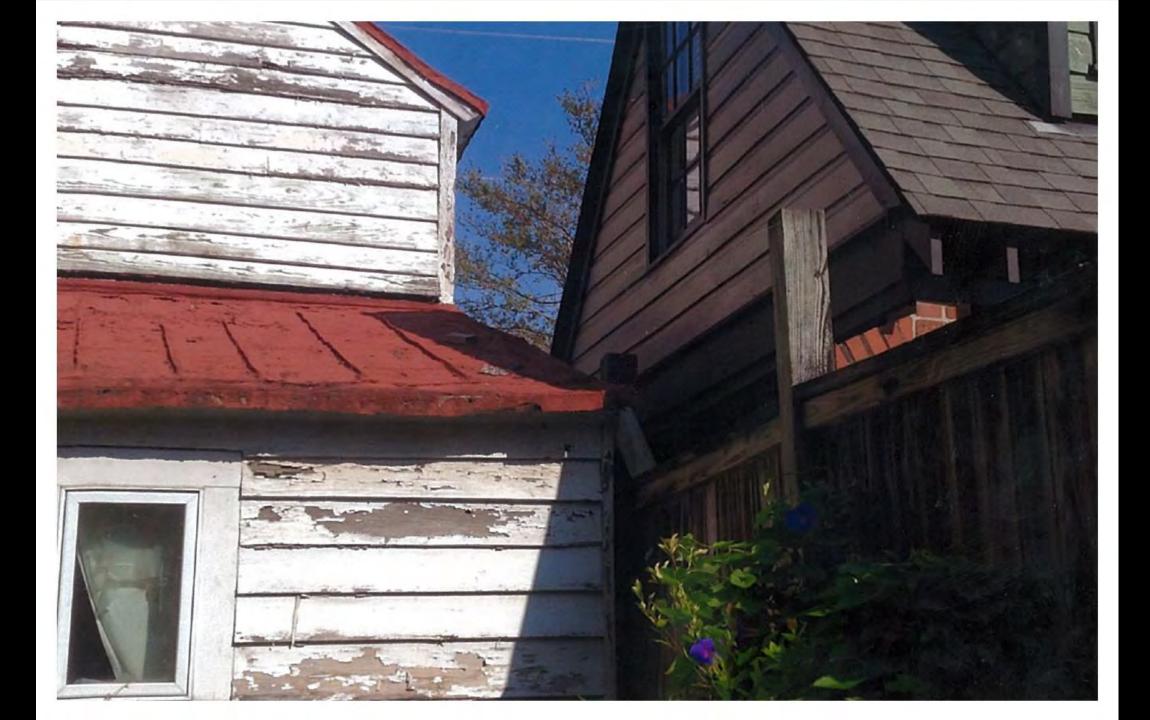
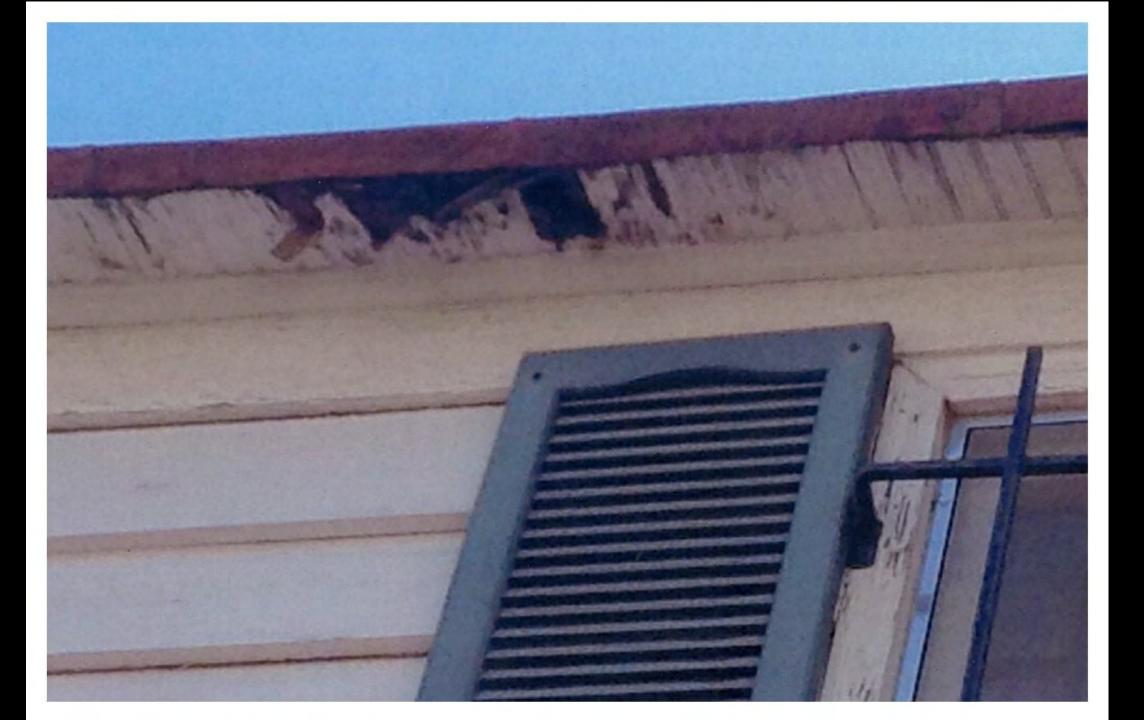
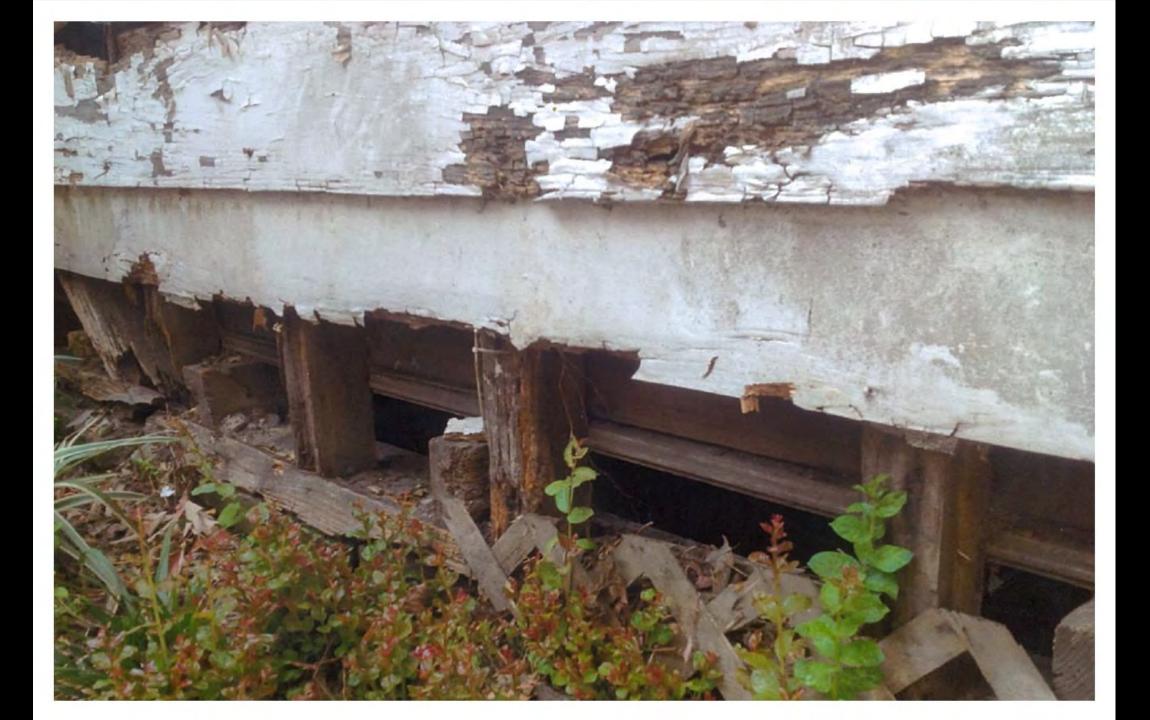
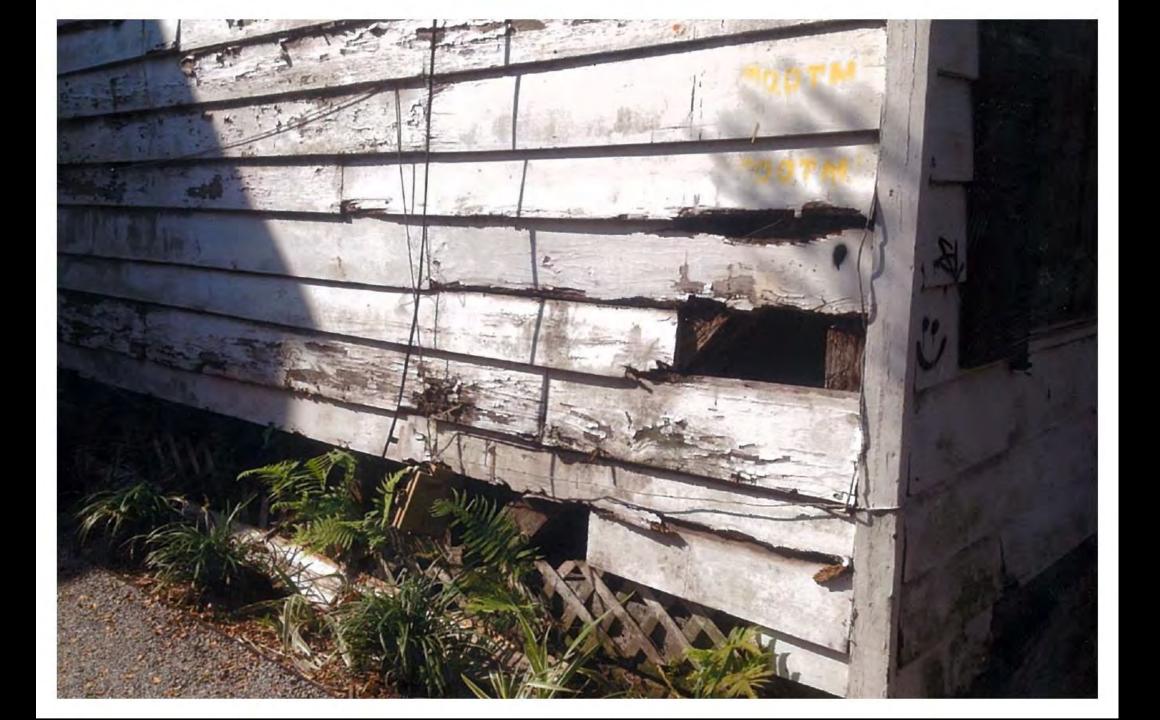
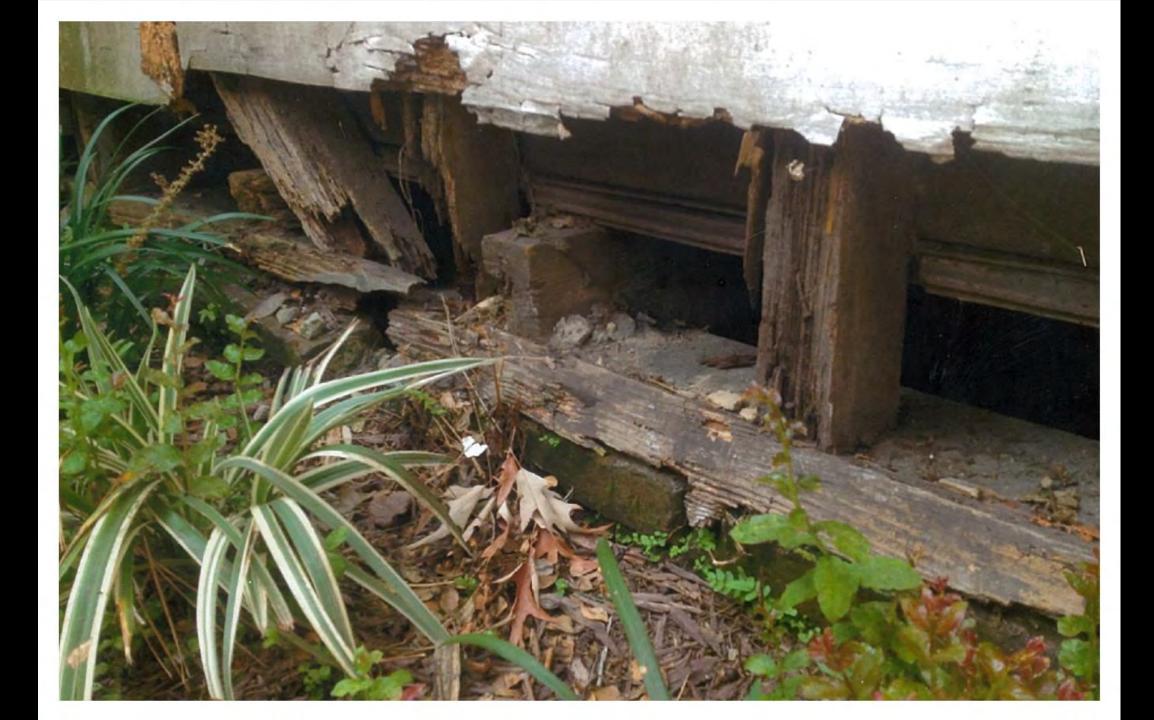
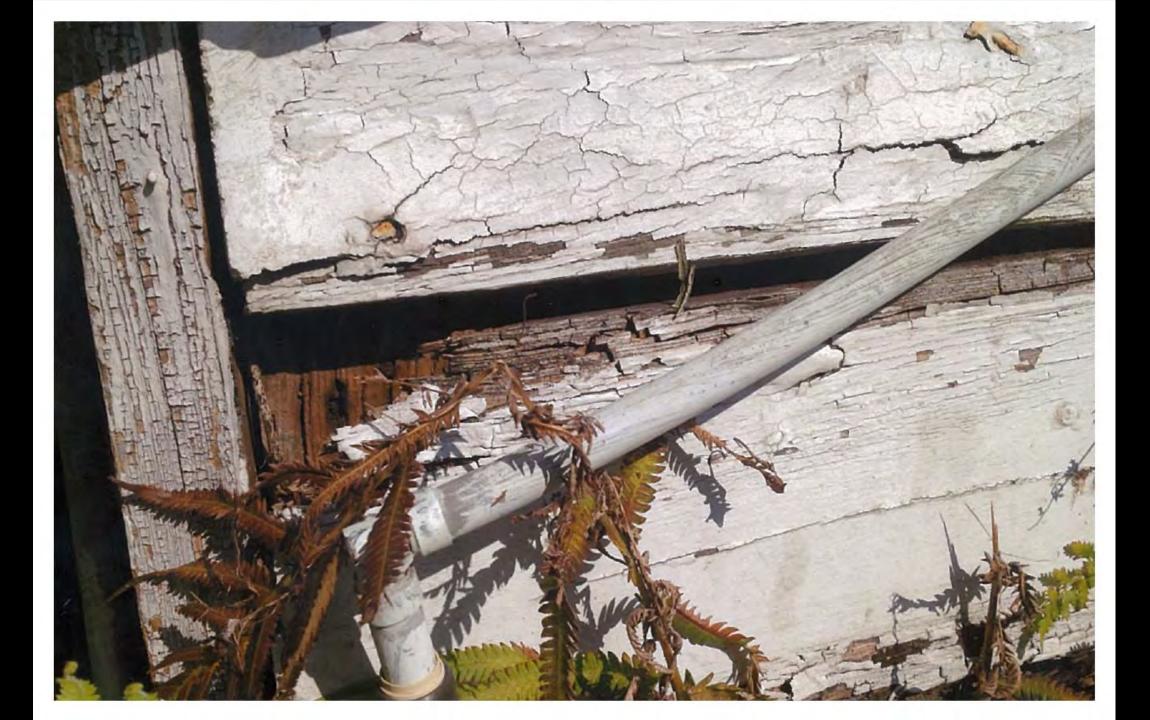
The second floor walls appear to be 2x stud walls. In those areas where the framing was visible, it appears to be in fair to poor condition. The walls were deflected or the there are indications of termite damage in the wall framing.

The second floor framing appears to be 2x wood joist at a regular spacing. The joists appear to span from the east (side) of the home to the west wall of the home. The joist themselves appear to be in poor to fair condition. There is significant deflection in the second floor with indications of both water damage and termite damage. There are portions of the second floor that cannot safely support any loading and are on the verge of collapse.

The first floor walls are framed with timber 2x studs spaced at roughly 16" o.c. There are areas where the studs are visible from the exterior. In those locations, typically at the building corners and near windows, the studs are in very poor condition. The studs exhibit signs of water damage and termite infestation. Many of the studs have lost considerable material and are completely failed. As we move away from the

corners and the windows, the condition of the studs improves. At present, we estimate that 50 to 60 percent of the studs at the first floor walls are in poor or failing condition.

The first floor framing consists of timber 2x joists that span from the one exterior sidewall to the other sidewall. The joists are supported at the perimeter by rim beams that span masonry piers. The rim beams appear to be heavy timber members. There are also timber beams beneath the interior load bearing wall. The condition of the joists at the first floor varies from fair to very poor. The perimeter beams are in very poor condition, suffering from a combination of water damage and insect infestation. Many of these beams are completely failed and have deflected several inches.

The home is founded on a crawl space foundation with brick masonry piers. The piers are approximately 12"x12" in size. The masonry piers are generally in poor condition. Most piers have loose bricks and some are listing and out of plumb. It is unclear if the piers are supported by concrete footings, but given the condition of the piers, the foundation system should be considered failed.

Due to the condition of the primary structural systems, we recommend that immediate actions be taken to shore the home against collapse. Currently, there are several piers that are leaning or severely damaged. Additionally, the floor beams supporting load bearing walls and the perimeter floor beams are in disrepair. Furthermore, the second-floor framing has failed and the second floor walls are in need of repair. These systems must be repaired or replaced or the structural stability of the entire home could be compromised. In addition to the replacement of failed systems, sheathing should be added to the roofing and exterior walls. Given the wholesale replacement of the 2nd floor walls, 2nd floor framing, 1nd floor walls, first floor framing, and foundation systems, demolition and reconstruction may be a more viable option. There is very little of the existing structure that can be salvaged.

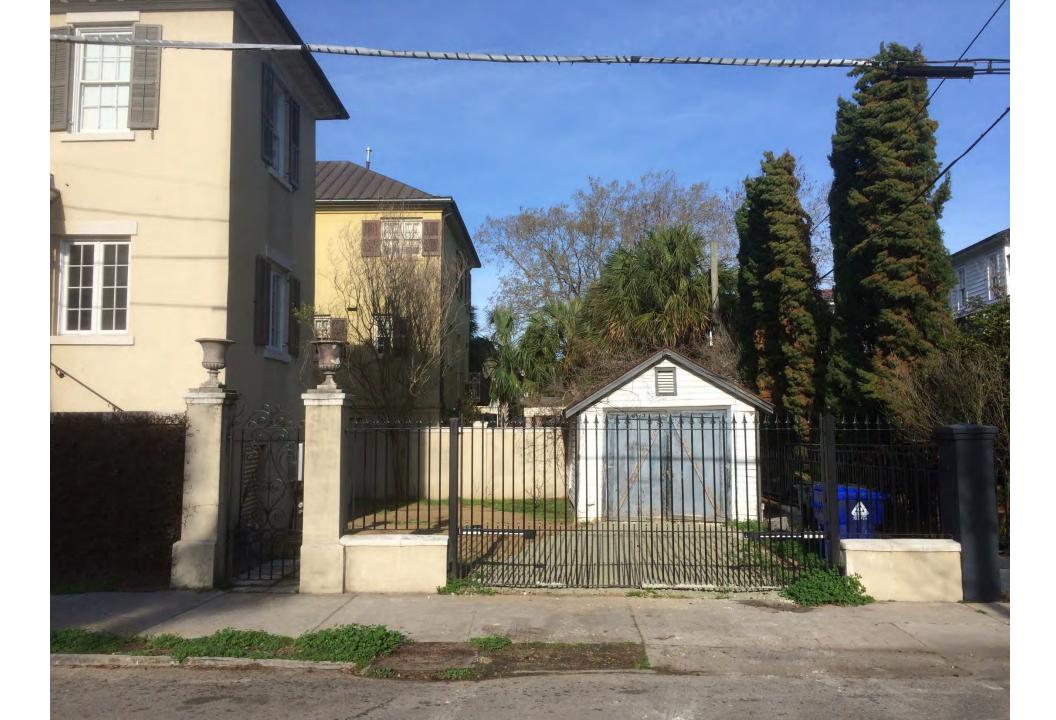
- 1. The existing structure is approx. 12'-0 x 20' wood structure (Photos 1& 2).
- The existing structure consists of 2x4 stud walls and is supported by concrete foundation.
 The concrete is only 6"x8" deep with no reinforcement. The concrete footing is cracked and broken (Photos 3 & 4).

In our professional opinion, we recommend to demolish the existing structure and build new structure with properly designed foundation system & super structure on sloped grade for water runoff.

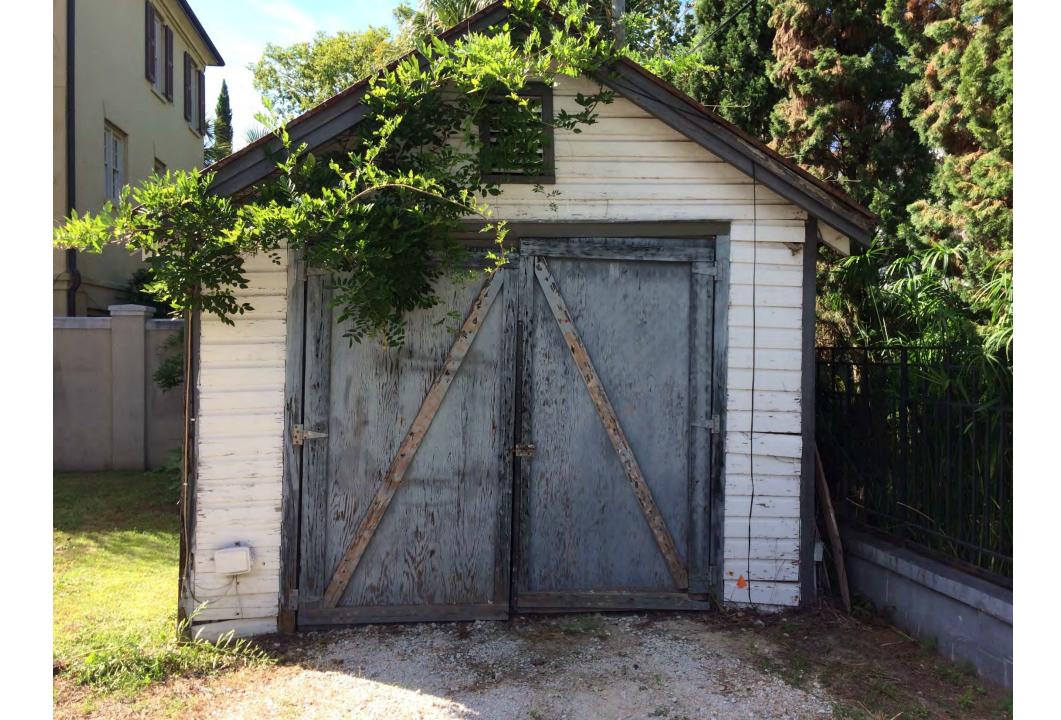
- The floor of the structure is supported on 4x4 laid on ground (Photo 5). The floor sheathing is rotted and floor is uneven.
- The left side stud wall is bowed (Photo 6). The studs are rotted at bottom. Few studs have been sistered with 2x4. The sill plate is rotted and there are no anchors to the foundation concrete.

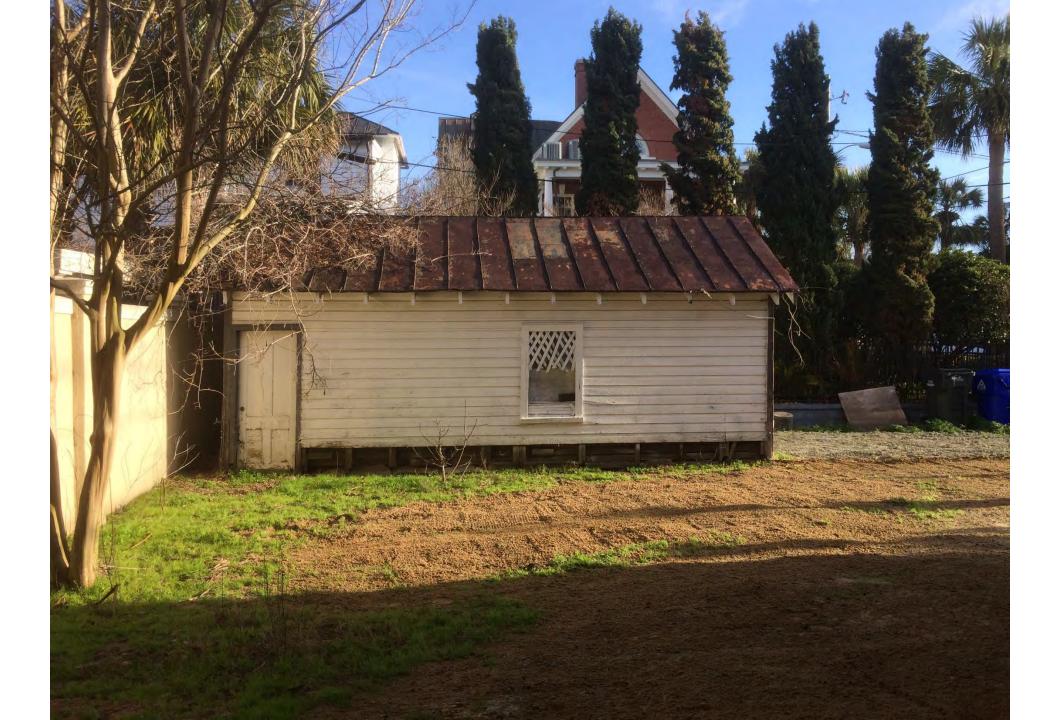
- The rear side wall has substantial termite damaged to stude and wood siding members (Photos 7 & 8).
- 6. The metal roof is damaged and has excessive rust (Photo 9).

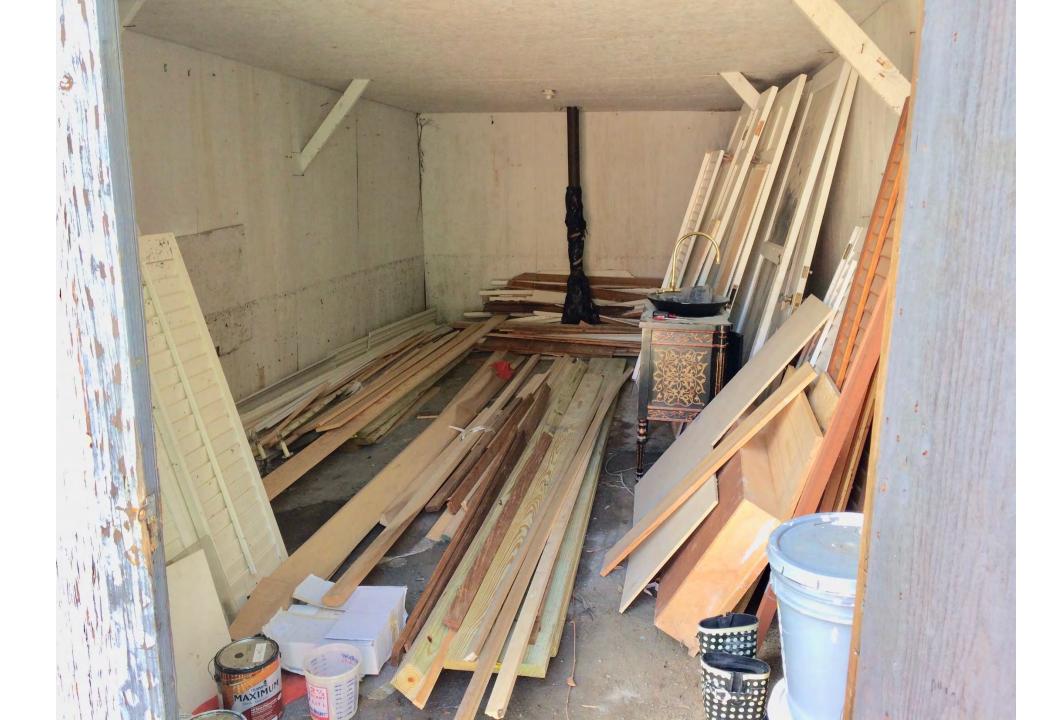
- 7. The roof rafters don't have any hurricane straps installed (Photo 10).
- The Right side of building is in accessible (Photo 11). There is visible damage to the sill and studs.
