## City of Charleston

# Board of Architectural Review-LARGE September 25, 2019

551 Meeting Street - - TMS # 459-05-01-015

RE: Structural Analysis of Existing Framing 551 Meeting St. Charleston, SC Tobias & West, LLC Project # 18-078

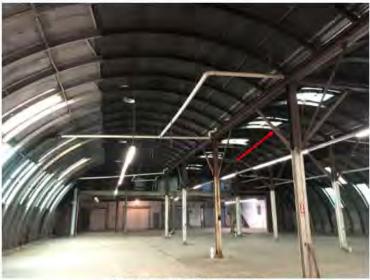
Picture 3 -Knee braces at columns

551 Meeting Street – Charleston, SC – September 13, 2019 Pg. 3 of 6 – *Tobias & West, LLC*  The lateral resistance to wind and seismic loads is achieved by use of steel angles serving as knee braces on the columns along both column lines (See Picture 3). These type connections are not approved for high-seismic locations. I recommend removing the columns in 8 locations and replacing with steel moment frames that meet the current seismic design standards. See Pictures 4 and 5 for the anticipated frame locations and a typical moment frame elevation.

The front entry wall of the building is unreinforced masonry block and will be insufficient to resist seismic or wind lateral loads. This wall must be removed and replaced with either a new properly designed masonry shear wall or a steel moment frame. The anticipated steel moment frame location is shown in Picture 4 on the next page. New footings will be required at the moment frame column locations.
